1. INTRODUCTION

The Ribbesford Conservation Area (the Area) was designated by Wyre Forest District Council in 1991. It is situated about 1 mile (1.4 km) to the south of Bewdley, in the county of Worcestershire. It comprises a small rural hamlet with buildings dating primarily from the sixteenth to nineteenth centuries, set in the valley of the River Severn against a steep wooded hill-side.

This document aims to set out the special architectural and historic characteristics of the Conservation Area. The character appraisal will be of interest and use to those involved with development and use of the area, and that adjoining it, to preserve and enhance the Area's character.

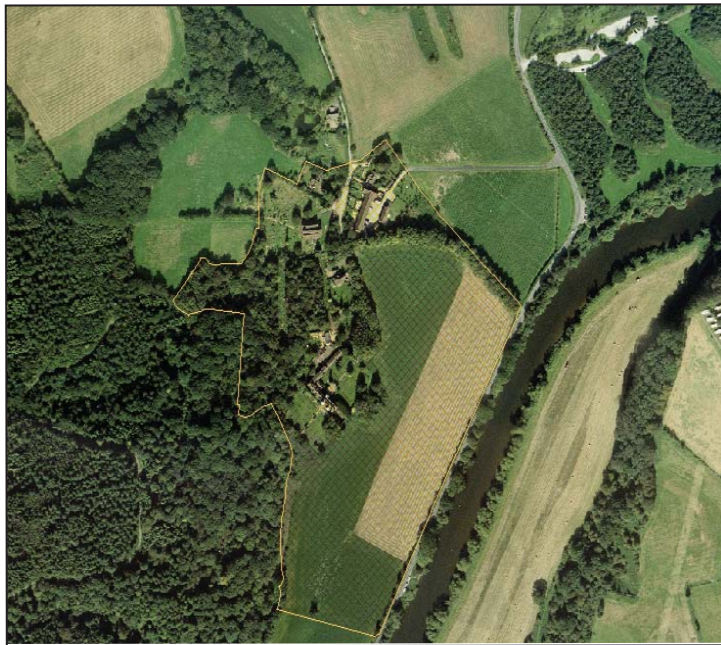
An aerial view of Ribbesford Conservation Area and its setting

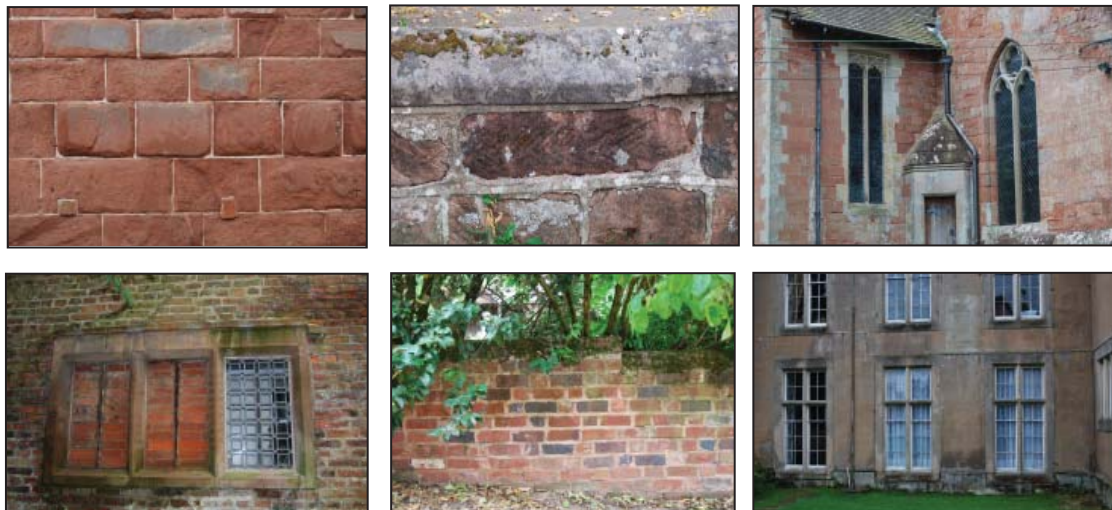
Local red sandstone is the dominant building material in the Area, with both the church and surrounding wall, together with the Tithe barn constructed in dressed sandstone, in random coursing, with narrow mortar joints; this is complimented with a local green/ white limestone used for dressings, such as quoins and window surrounds.

Red brick is used in the rest of the buildings, with outhouses and side wings of Ribbesford House, Home Farm and the more modern properties in the Area all being constructed in a variety of different bricks. Different renders are also present, from the stucco render on the manor house, to the pebbledash on Church Cottage. Mortars also vary from the rich creamy white traditional lime mortars, to a more modern brown cement.

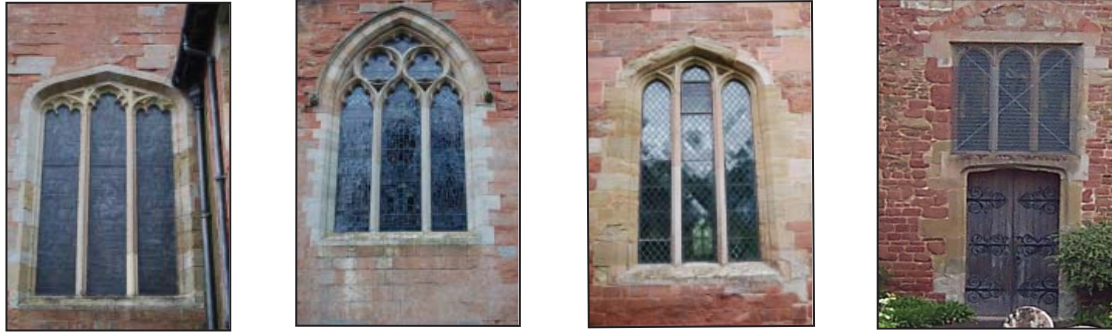
The church has a range of windows, varying through the differing periods of construction and extension, reflecting the changes in church architecture and design, ranging from lancet and tri-arched windows through to decorative tracery, all set in local green sandstone.

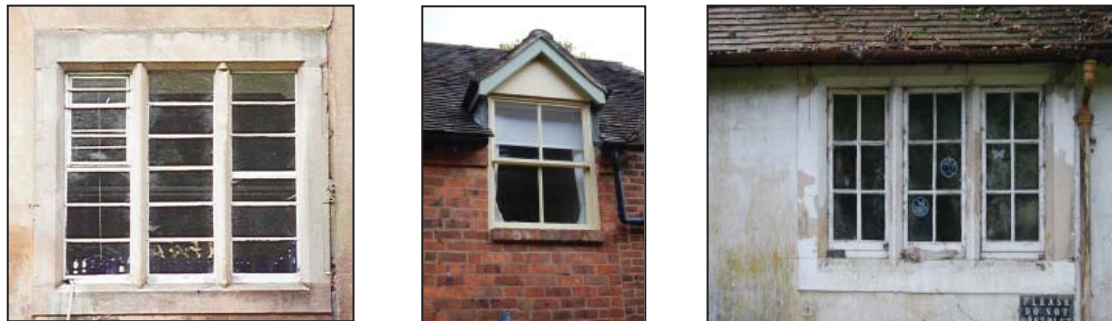
Ribbesford House has a selection of different windows, reflecting the status of the various elements of the house. Full length timber sash windows are present on the main building, whilst Crittle-styled metal-framed windows are more common on the out-buildings, often either side or top-hung casements. The front elevation of the House also has metal-framed windows, but set within dressed limestone mullions.

The cottages retain the traditional style of 3-light side-hung timber casements, painted white.

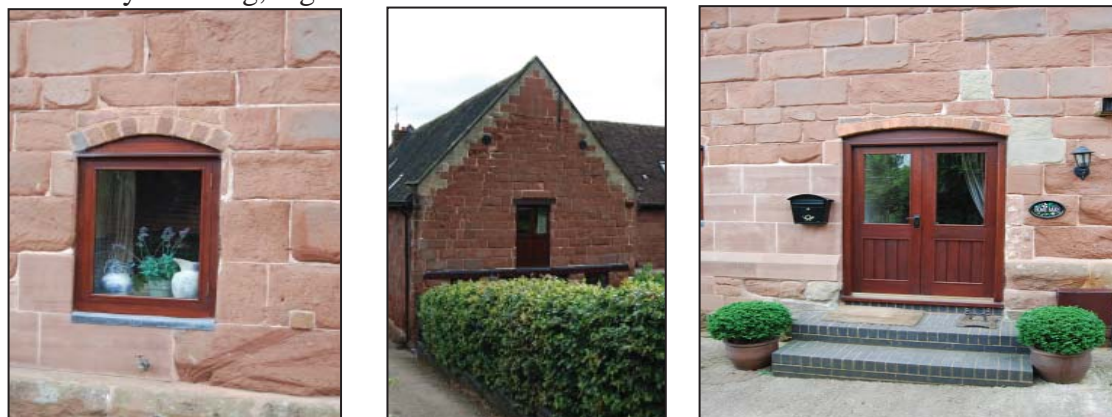
The barn conversions retain some of the original openings, such as the elliptical windows to the gable of the main barn, and also introduce a style of windows commonly associated with such conversion, utilising a stained timber frame, with thick transoms and heavy detailing, together with stable-effect infills.

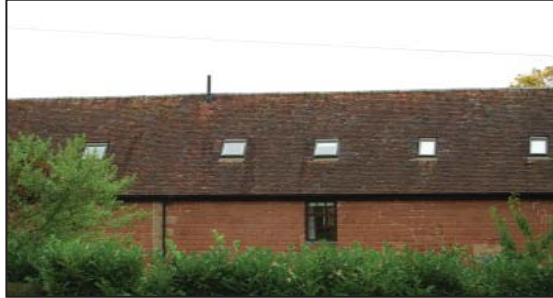
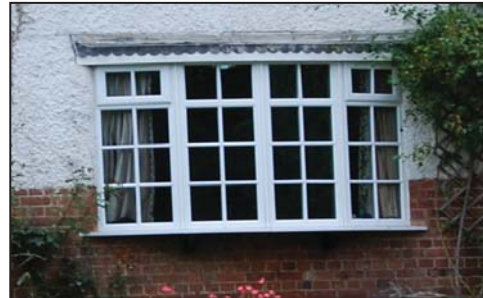
Roof-lights are present, especially on the barn conversions. However, these are dated in appearance, and do not have the detailing associated with the conservation-style roof-lights. They are also heavily concentrated on the roof-slopes with the greatest impact on the Conservation Area, rather than aiming to minimise this impact.

There are some Upvc windows in the more modern properties, which are considered as highly inappropriate, especially within such a small hamlet, where the use of such materials has a larger than usual impact on the character and appearance of the Conservation Area.

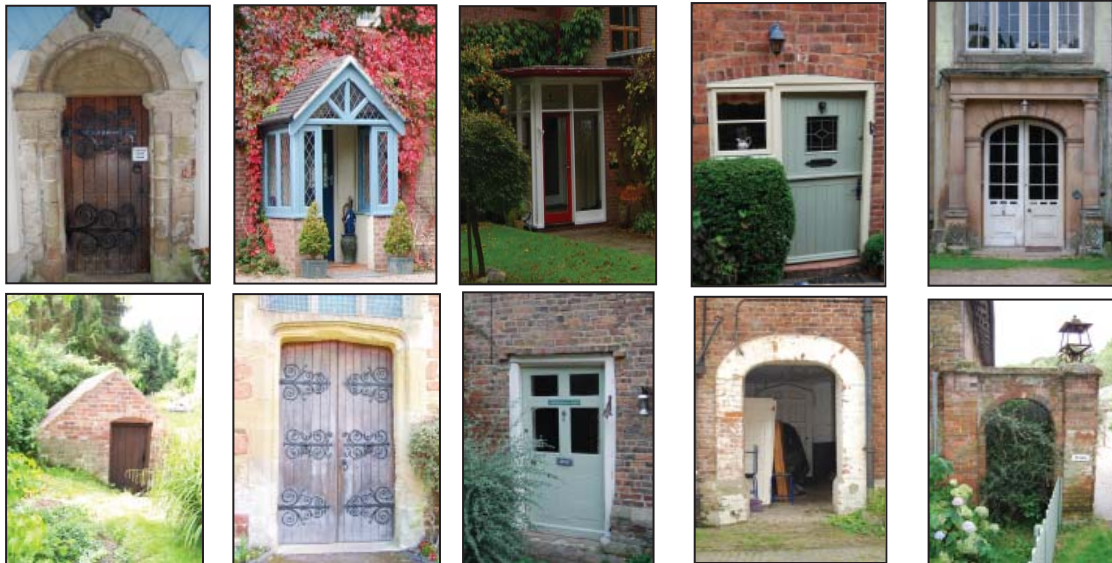
The two main entrances to the Church, to the north elevation and the west elevation, are oak ledged and braced doors, with highly ornamental brackets and hinges. The main door at the western end of the church is framed with sandstone ashlar linking it to the main west window, and sits under a four-centred arch. The northern door is surrounded by a timber porch, and framed with decorative carved sandstone detailing and motifs, including centaurs and birds (both forms of Medieval symbolism), indicating that this frame has been moved, during the construction of this element of the church during the C17th.

The manor house has various entrances, reflecting the status of the building, with different entrances dependant on status. These range from a three-centred arch, with partially glazed timber double doors acting as the principal entrance, through to painted ledged and braced doors on the stable block.

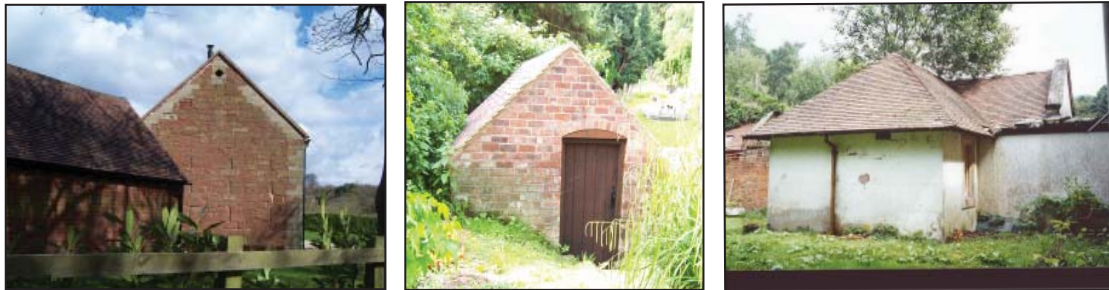
The principal roofing material within the Area is a modern red clay Rosemary tile, and whilst there are some traditional hand-made tiles, these tend to be mixed in with the modern, flatter versions. Ridges are covered in red ridge tiles – these are predominantly half-round in style, although the church does have ornamental ridge tiles.

Pitches are a uniform 45 °, with many roofs having parapets to finish the gables off.
