Wyre Forest District Council

**DRAFT
CHARACTER APPRAISAL
FOR
RIBBESFORD
CONSERVATION AREA**

JANUARY 2010

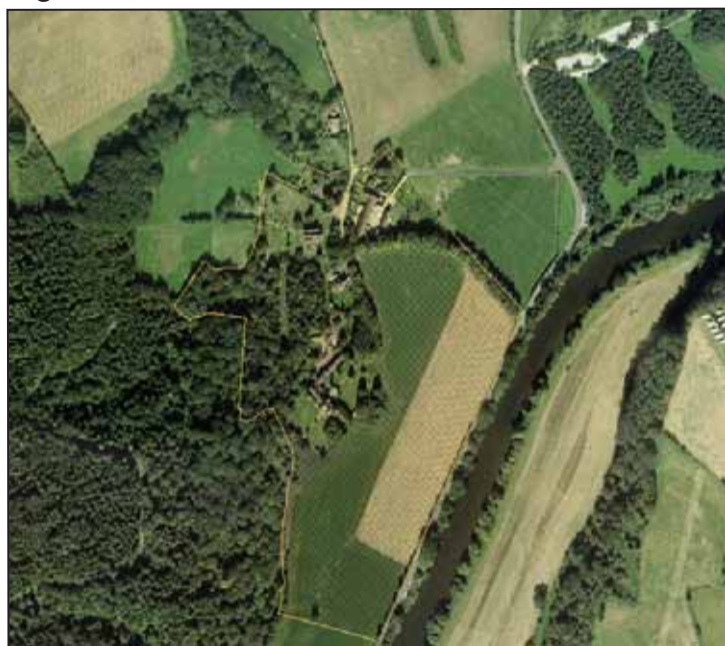
An aerial view of Ribbesford Conservation Area and its setting

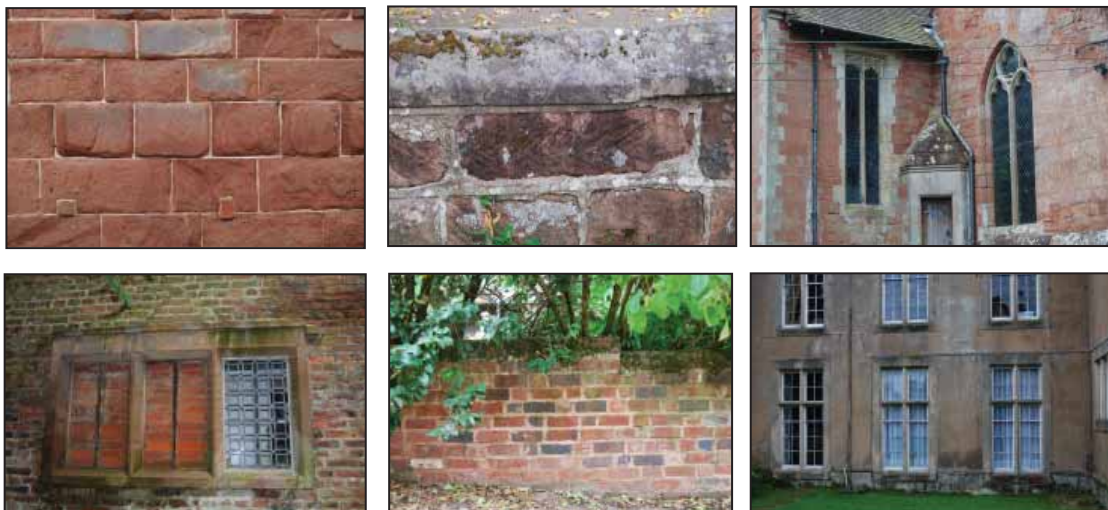
Local red sandstone is the dominant building material in the Area, with both the church and surrounding wall, together with the Tithe barn constructed in dressed sandstone, in random coursing, with narrow mortar joints; this is complimented with a local green/white limestone used for dressings, such as quoins and window surrounds.

Red brick is used in the rest of the buildings, with outhouses and side wings of Ribbesford House, Home Farm and the more modern properties in the Area all being constructed in a variety of different bricks. Different renders are also present, from the stucco render on the manor house, to the pebbledash on Church Cottage. Mortars also vary from the rich creamy white traditional lime mortars, to a more modern brown cement.

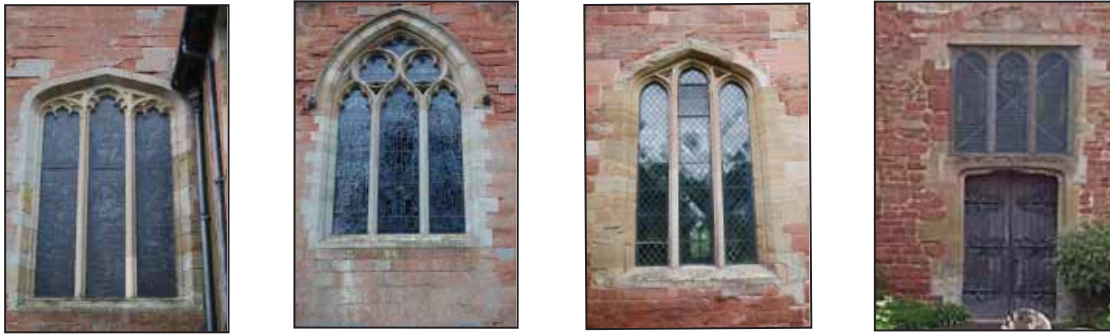
The church has a range of windows, varying through the differing periods of construction and extension, reflecting the changes in church architecture and design, ranging from lancet and tri-arched windows through to decorative tracery, all set in local green sandstone.

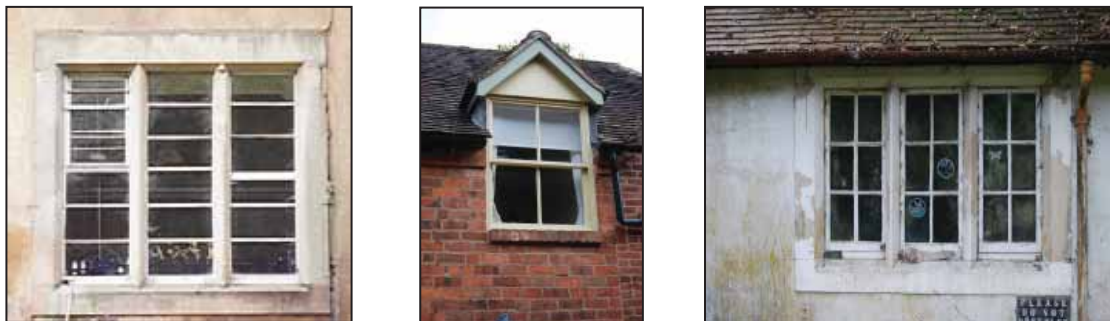
Ribbesford House has a selection of different windows, reflecting the status of the various elements of the house. Full length timber sash windows are present on the main building, whilst Crittle-styled metal-framed windows are more common on the outbuildings, often either side or top-hung casements. The front elevation of the House also has metal-framed windows, but set within dressed limestone mullions.

The cottages retain the traditional style of 3-light side-hung timber casements, painted white.

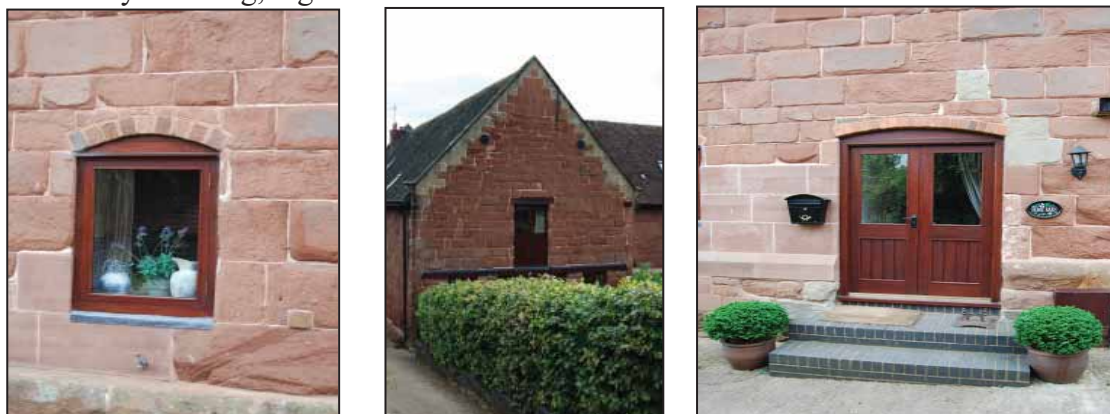
The barn conversions retain some of the original openings, such as the elliptical windows to the gable of the main barn, and also introduce a style of windows commonly associated with such conversion, utilising a stained timber frame, with thick transoms and heavy detailing, together with stable-effect infills.

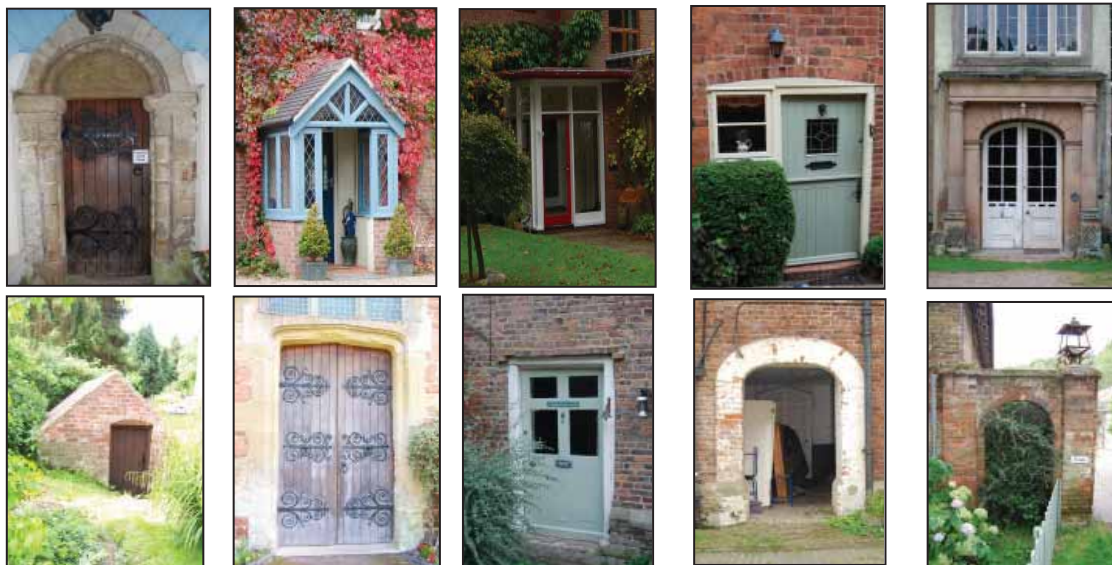
The two main entrances to the Church, to the north elevation and the west elevation, are oak ledged and braced doors, with highly ornamental brackets and hinges. The main door at the western end of the church is framed with sandstone ashlar linking it to the main west window, and sits under a four-centred arch. The northern door is surrounded by a timber porch, and framed with decorative carved sandstone detailing and motifs, including centaurs and birds (both forms of Medieval symbolism), indicating that this frame has been moved, during the construction of this element of the church during the C17th.

The manor house has various entrances, reflecting the status of the building, with different entrances dependant on status. These range from a three-centred arch, with partially glazed timber double doors acting as the principal entrance, through to painted ledged and braced doors on the stable block.

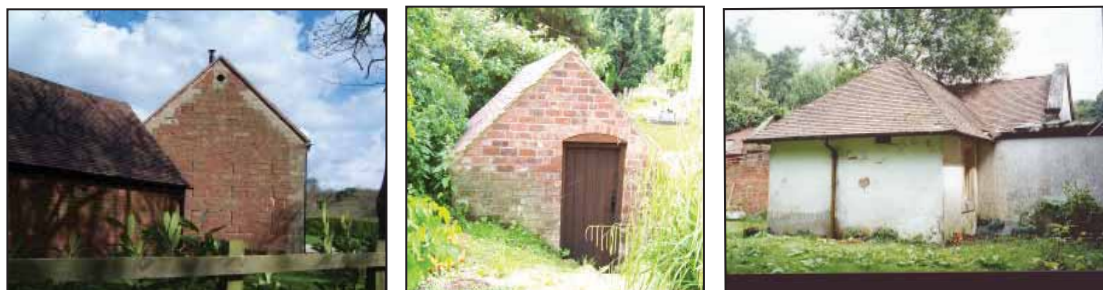
The principal roofing material within the Area is a modern red clay Rosemary tile, and whilst there are some traditional hand-made tiles, these tend to be mixed in with the modern, flatter versions. Ridges are covered in red ridge tiles – these are predominantly half-round in style, although the church does have ornamental ridge tiles.

Pitches are a uniform 45 °, with many roofs having parapets to finish the gables off.

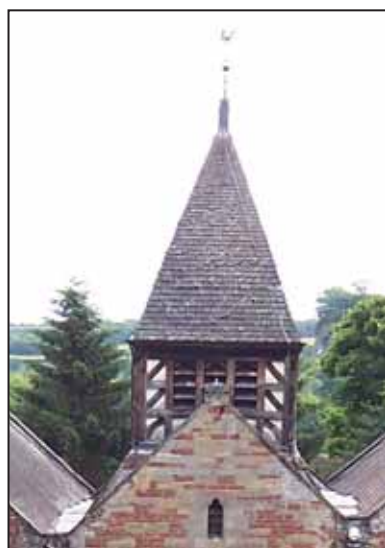
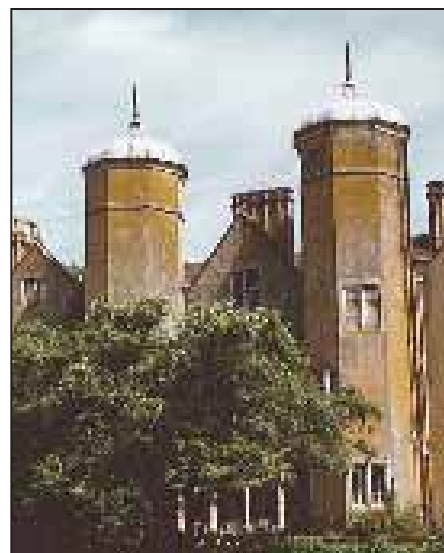
There are some small variations to these, although they are usually on details of buildings. The church spire is covered in cedar shingles, with a roof pitch of 60°, and Ribbesford House has two towers capped with squat helmet domes, covered in lead.

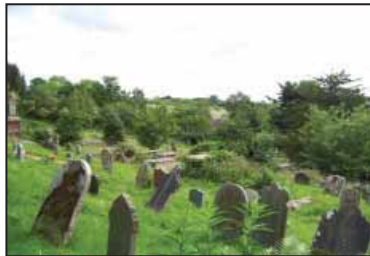
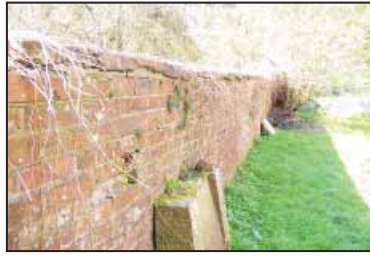
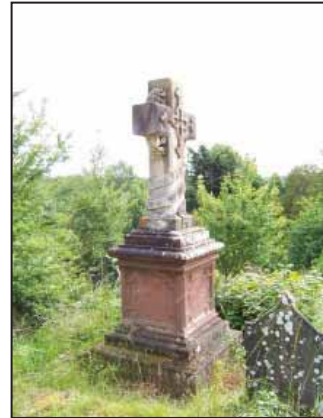
The churchyard has retained much of its character, with many of the important graves retaining their headstones in situ, and wrought iron fences surrounding the stones, together with the boundary walls, and the bier house on the eastern boundary wall.
