Wyre Forest District Council

**DRAFT
CHARACTER APPRAISAL
FOR
RIBBESFORD
CONSERVATION AREA**

JANUARY 2010

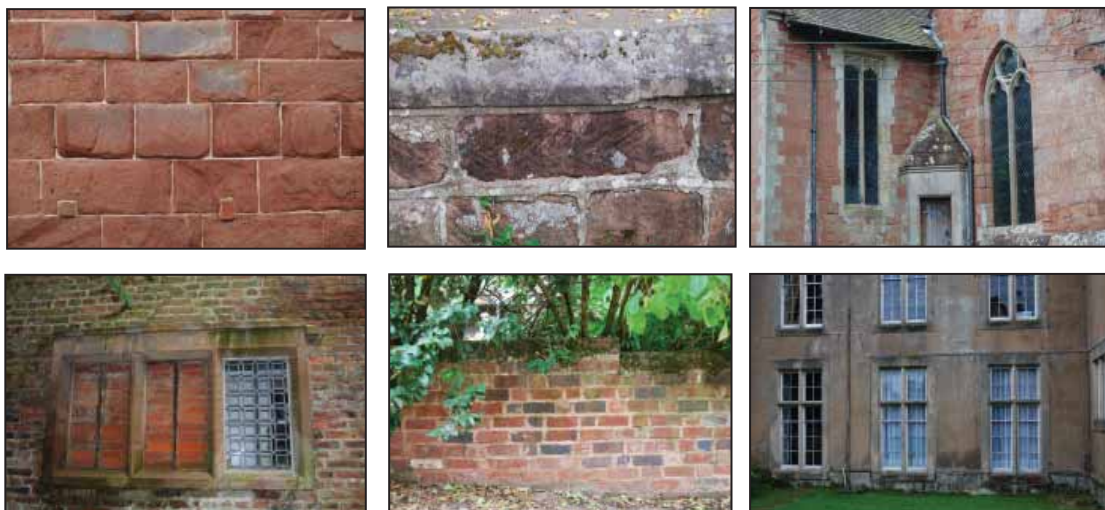
Local red sandstone is the dominant building material in the Area, with both the church and surrounding wall, together with the Tithe barn constructed in dressed sandstone, in random coursing, with narrow mortar joints; this is complimented with a local green/white limestone used for dressings, such as quoins and window surrounds.

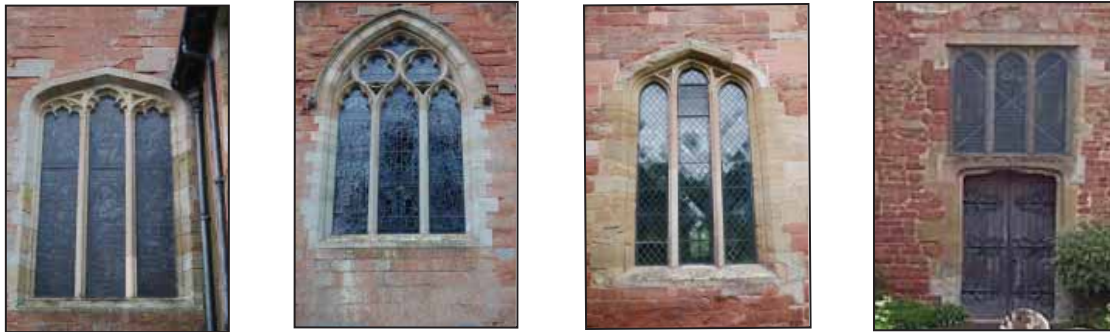
The church has a range of windows, varying through the differing periods of construction and extension, reflecting the changes in church architecture and design, ranging from lancet and tri-arched windows through to decorative tracery, all set in local green sandstone.

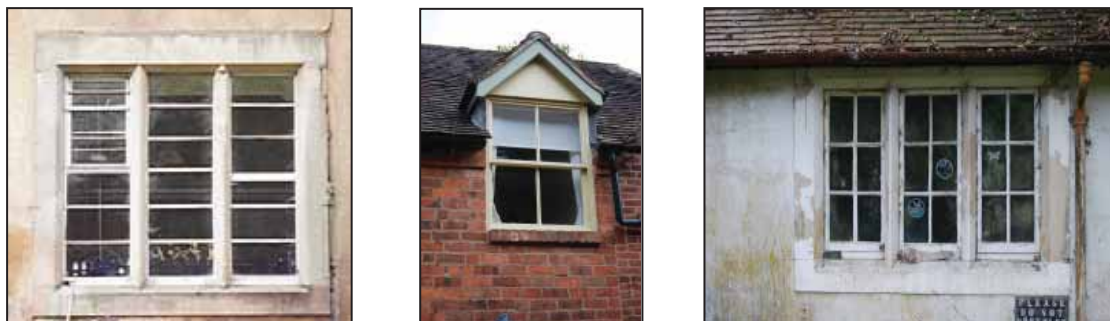
Ribbesford House has a selection of different windows, reflecting the status of the various elements of the house. Full length timber sash windows are present on the main building, whilst Crittle-styled metal-framed windows are more common on the outbuildings, often either side or top-hung casements. The front elevation of the House also has metal-framed windows, but set within dressed limestone mullions.

The cottages retain the traditional style of 3-light side-hung timber casements, painted white.

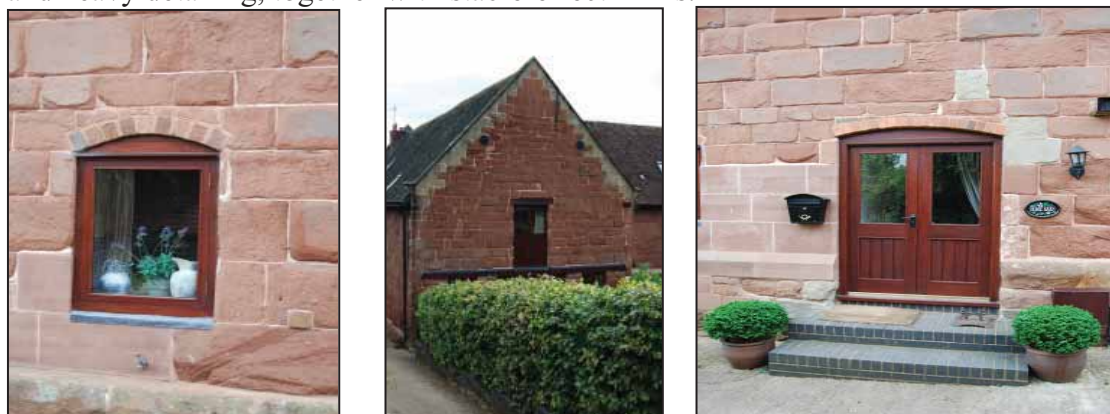
The barn conversions retain some of the original openings, such as the elliptical windows to the gable of the main barn, and also introduce a style of windows commonly associated with such conversion, utilising a stained timber frame, with thick transoms and heavy detailing, together with stable-effect infills.

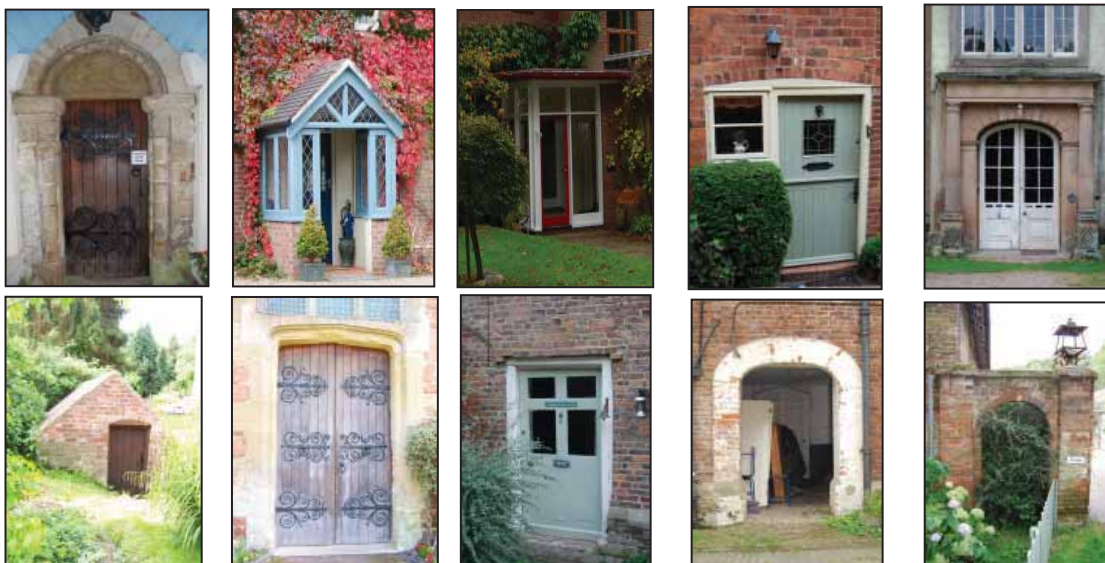
The two main entrances to the Church, to the north elevation and the west elevation, are oak ledged and braced doors, with highly ornamental brackets and hinges. The main door at the western end of the church is framed with sandstone ashlar linking it to the main west window, and sits under a four-centred arch. The northern door is surrounded by a timber porch, and framed with decorative carved sandstone detailing and motifs, including centaurs and birds (both forms of Medieval symbolism), indicating that this frame has been moved, during the construction of this element of the church during the C17th.

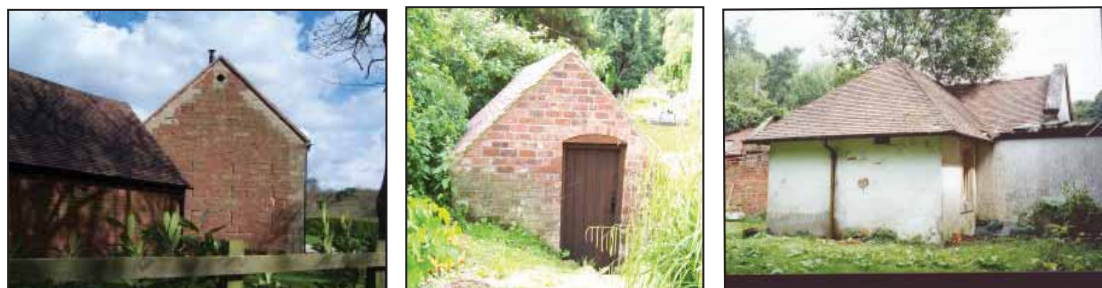
The principal roofing material within the Area is a modern red clay Rosemary tile, and whilst there are some traditional hand-made tiles, these tend to be mixed in with the modern, flatter versions. Ridges are covered in red ridge tiles – these are predominantly half-round in style, although the church does have ornamental ridge tiles.

Pitches are a uniform 45 °, with many roofs having parapets to finish the gables off.

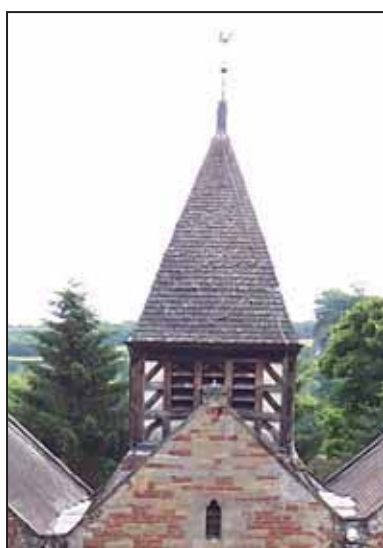
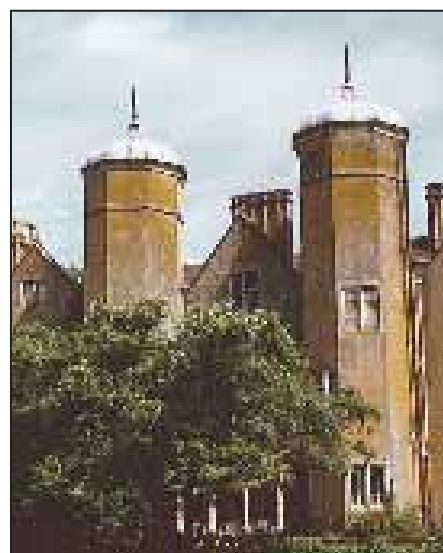
There are some small variations to these, although they are usually on details of buildings. The church spire is covered in cedar shingles, with a roof pitch of 60°, and Ribbesford House has two towers capped with squat helmet domes, covered in lead.
